Effect of Correlating Image Threshold Values with Image Gradient Field on Damage Detection in Composite Structures

Mahmoud Zaki Iskandarani
Faculty of Engineering
Al-Ahliyya Amman University, Amman-Jordan

Abstract—Effect of image threshold level variation is studied and proved to be a critical factor in damage detection and characterization of impacted composite Reaction Injection Molding ((RIM) structures. The variation of threshold is used as an input to both gradient field algorithm and segmentation algorithm. The choice of optimum threshold for a tested composite type is achieved as a result of correlation between the resulted gradient field images and segmented images. Type and extent of damage is also analyzed using detailed pixel distribution as a function of both impact energy and threshold level variation. The demonstrated cascading based technique is shown to be promising for an accurate testing and classification of damage in composite structures in many critical areas such as medical, aerospace and automotive.

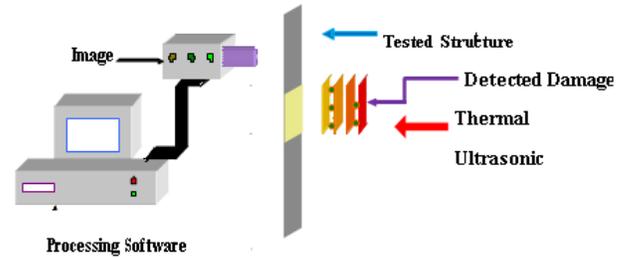
Fig. 1. Experimental Setup.

To achieve the intended purpose of this work, images of damaged structures at various impact energies are tested using MATLAB algorithm as shown in Fig. 1.

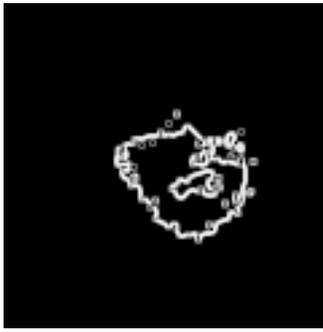
Fig. 2. Gradient Magnitude: 28J Impact, 0.57 Threshold.

The sampling resulted in the following pairs of correlated images as shown the respective figures: {(Fig. 2, Fig. 3), (Fig. 4, Fig. 5), (Fig. 6, Fig. 7), Fig. 8, Fig. 9)}.

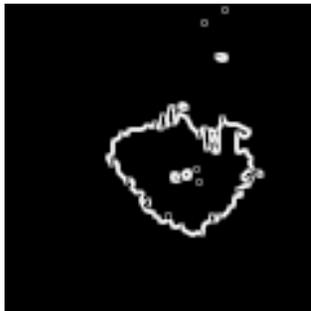
Fig. 4. Gradient Magnitude: 28J Impact, 0.60 Threshold.

Fig. 5. Edge Segmentation: 28J Impact, 0.60 Threshold (Optimum Segmentation).

Features of the damaged area started to appear at threshold value of 0.43, with optimum features at threshold value of 0.60. The damaged area stated to merge with the surrounded areas at threshold value of 0.61 with total merge at threshold value of 0.67.

The correlation resulted in one optimum threshold value for an impact energy of 28J, which is 0.60. The algorithm will take this value as a second parameter and correlate it to the impact energy. Hence, a new pair is resulted, {28J, 0.6}.

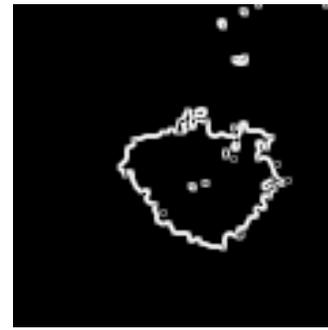
Fig. 6. Gradient Magnitude: 28J Impact, 0.61 Threshold.

Fig. 7. Edge Segmentation: 28J Impact, 0.61 Threshold (No Segmentation Possible).

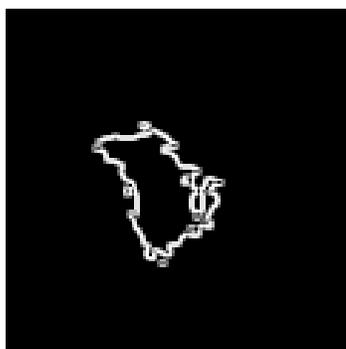
Fig. 10. Gradient Magnitude: 42J Impact, 0.41 Threshold.

The sampling resulted in the following pairs of correlated images as shown in the respective figures: {(Fig. 10, Fig. 11), (Fig. 12, Fig. 13), (Fig. 14, Fig. 15), Fig. 16, Fig. 17), (Fig. 18, Fig. 19)}.

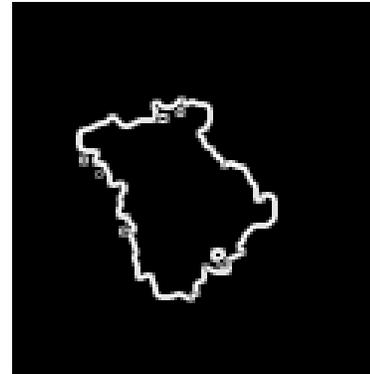
Fig. 12. Gradient Magnitude: 42J Impact, 0.48 Threshold.

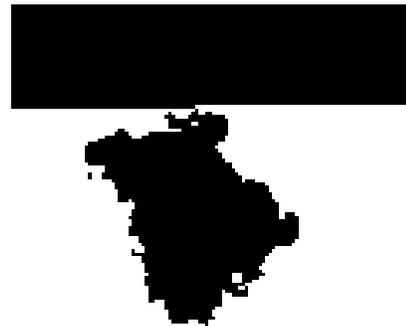
Fig. 13. Edge Segmentation: 42J Impact, 0.48 Threshold.

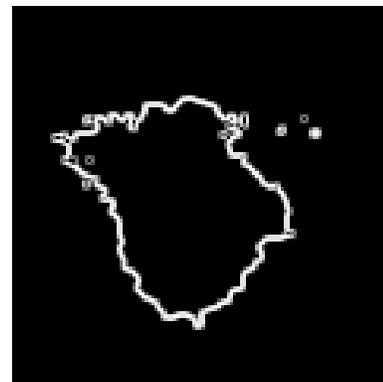
Fig. 14. Gradient Magnitude: 42J Impact, 0.52 Threshold.

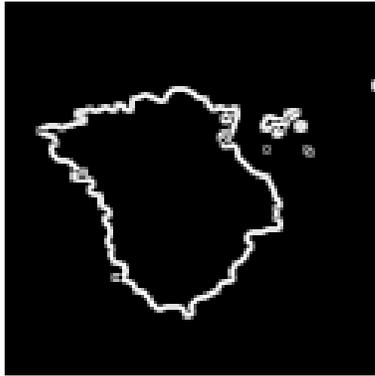
Fig. 16. Gradient Magnitude: 42J Impact, 0.53 Threshold.

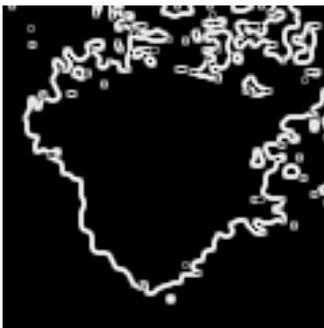
Fig. 18. Gradient Magnitude: 42J Impact, 0.60 Threshold.

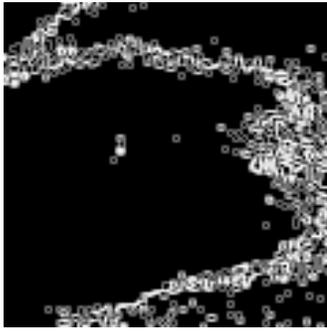
Fig. 20. Gradient Magnitude: 56J Impact, 0.31 Threshold.

The sampling resulted in the following pairs of correlated images as shown in the respective figures: {(Fig. 20, Fig. 21), (Fig. 22, Fig. 23), (Fig. 24, Fig. 25)}

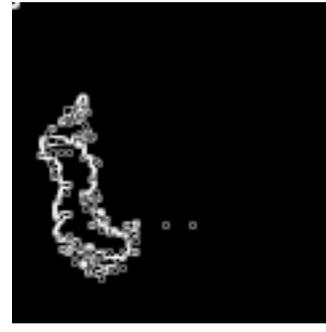
Fig. 24. Gradient Magnitude: 56J Impact, 0.51 Threshold.

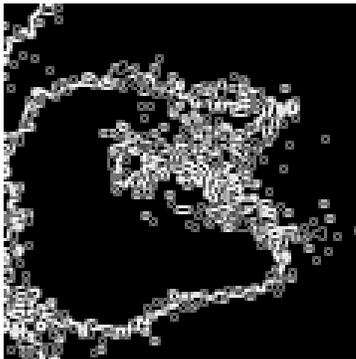
Fig. 22. Gradient Magnitude: 56J Impact, 0.37 Threshold.

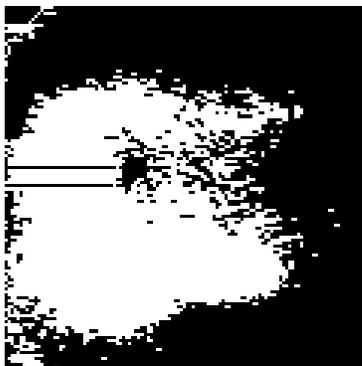
Fig. 23. Edge Segmentation 42J Impact, 0.37 Threshold (No Segmentation Possible).

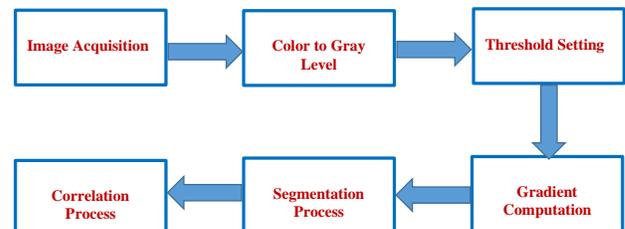
Fig. 26. Image processing system

Fig. 26 shows the used system for impact damage analysis, while Tables I to III and Fig. 2 to 25 show the resulting gradient and segmented images.

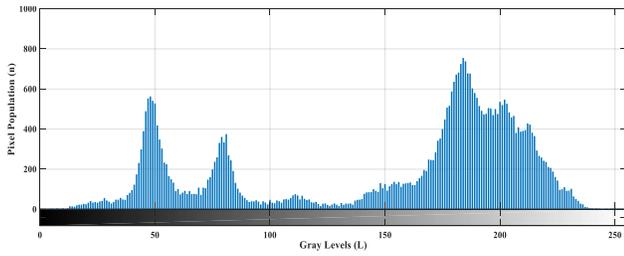
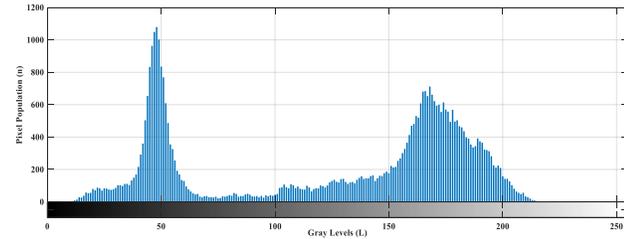
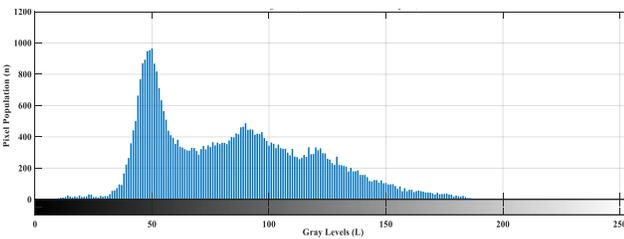
Fig. 27. Image Histogram: 28J Impact, 0.60 Threshold.

Fig. 28. Image Histogram: 42J Impact, 0.52 Threshold.

Fig. 29. Image Histogram: 56J Impact, 0.37 Threshold.

Fig. 27 to 29 show histograms obtained for three impact energies. From the histograms, it is clear that at 56J impact, a dramatic change occurs in the tested composite structure, which is fiber breakage and pull out. Thus affecting pixel values and distribution pattern, and resulting in a unique statistical accumulation.

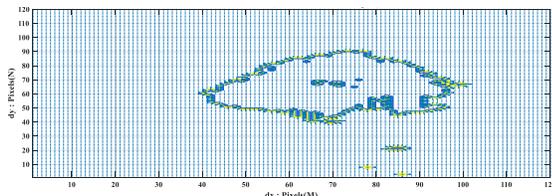
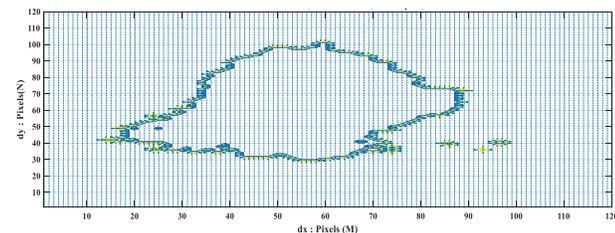
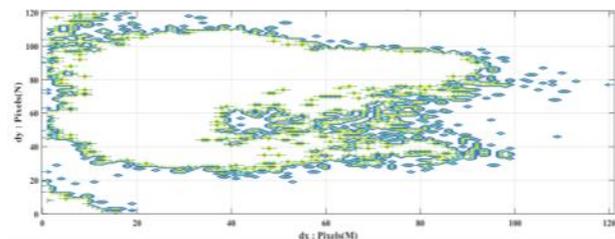
Fig. 30. Gradient Field Contour: 28J Impact, 0.60 Threshold.

Fig. 31. Gradient Field Contour: 42J Impact, 0.52 Threshold.

Fig. 32. Gradient Field Contour: 56J Impact, 0.37 Threshold.

The obtained histogram results correlates well with gradient contours shown in Fig. 30-32, where at 56J different characteristics are presented with the effect of impact is more marked and no evidence of localized damage as in the cases of 28J and 42J impact energy levels.

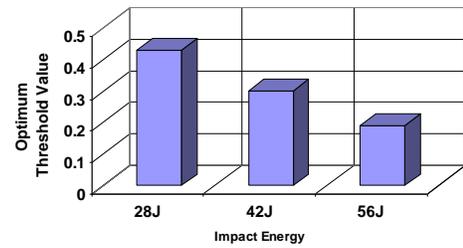
Fig. 33. Relationship between Impact Energy and Selected Threshold.

Fig. 33 presents a direct relationship between Impact Energy and Gradient Field Area. This is logical as the higher the impact energy the larger the affected area.

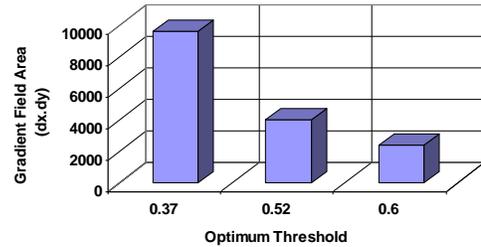
Fig. 34. Relationship between Optimum Threshold and Gradient Field Area.

Fig. 34 presents an inverse relationship between the selected Threshold and Gradient Field Area. This is also logical, since the more the affected area, the less of Threshold Value is required to uncover the affected region boundaries. This is also consistent with increasing the Impact Energy.

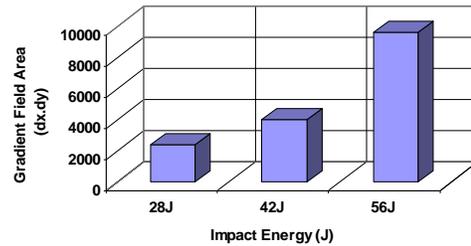
Fig. 35. Relationship between Impact Energy and Gradient Field Area.

Fig. 35 establishes the relationship between Impact Energy and Gradient Field Area, which is a direct relationship as deduced from Fig. 34.

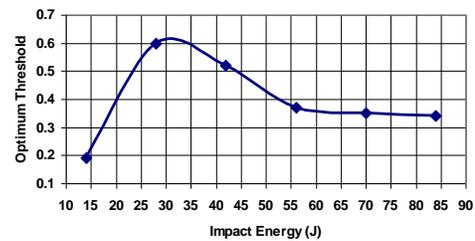
Fig. 36. Relationship between Impact Energy Optimum Threshold.

From Equation (1), we can reproduce a guiding curve describing the relationship between Required Optimum Threshold to uncover damage level and Impact Energy, as shown in Fig. 36.

From the plot, the three main bounding conditions are clear:

1) At very low Impact Energies, the composite sample will have negligible damage, hence, the sample and surface will possess uniform structure and that reduces the Optimum Threshold value to a very low level. Such Levels of Impact Energies can be neglected as it will not affect component safety and reliability.

2) At Lower Impact Energies, there is an evidence of damage and surface deformation as the Optimum Threshold increases.

3) At Higher Impact Energies, most of the tested component is damage as the damage propagates both in depth and breadth. This is a critical case of damage.
