An IoT Solution to Detect Overheated Idler Rollers in Belt Conveyors

Abstract—It is common knowledge that mechanical systems need oversight and maintenance procedures. There are numerous prevalent operation monitoring techniques, and in the era of IoT and predictive maintenance, it is possible to find multiple solutions to supervise these systems. This article describes the design and implementation of a low-cost system, which use an IoT approach to detect overheated idlers in conveyors belt in mining facilities. The system involves the use of temperature sensors, coordinately with heat map image sensors. The users (i.e., mining operators) can monitor overheated idlers in the whole conveyor belt, making on-demand queries using Telegram or a website, and also receiving autonomous warnings. Prototypes of this system were installed on a conveyor belt at a construction materials manufacturing company, and also in a copper mining company, both located in Apurímac, Peru. The usability and usefulness of the system were evaluated by 20 experts in maintenance and operation of conveyor belts, who filled the questionnaire proposed by TAM (Technology Acceptance Model). The results show that 9

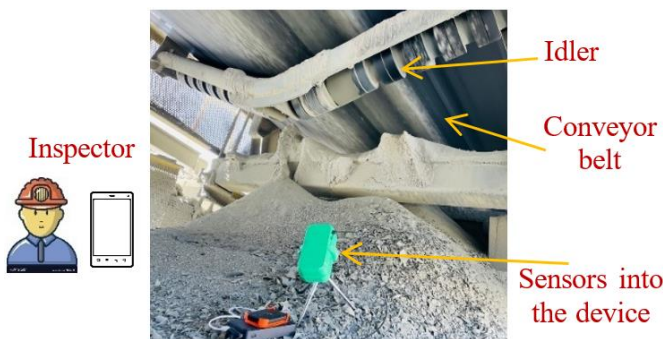
Fig. 1. The prototype installed in “MMG Las Bambas” mining company (Peru).

The prototype of the system is inside the green casing shown in Fig. 1; it is located near the idler of the conveyor belt. The system includes three main components: a) a temperature sensor that measures the temperature of the idler; b) a thermographic image sensor that obtains a heat map of the idler; and c) a video camera that takes snapshots of the current state of the idler rollers to see if there is dust or sand around it. This latter component also records video to see the movement and hear the noise that the idler could generate.

The prototype is placed near the idler on a conveyor belt, then the person responsible for monitoring can make queries using their mobile device through the Telegram social network, and the system responds with the temperature, photo, heat map or video depending on the request. This allows monitoring the heating of the idler on a conveyor belt over time.

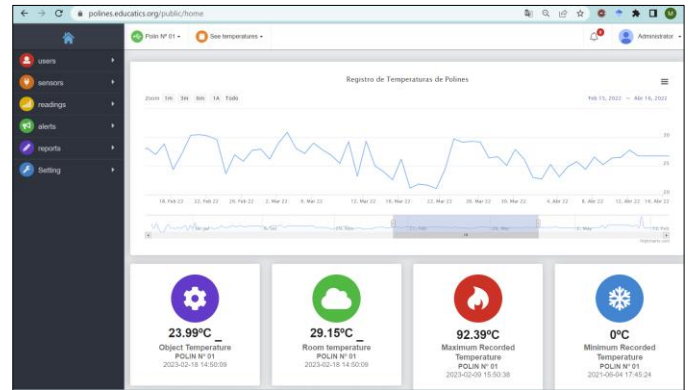
Fig. 3. The website panel for monitoring temperature.

The URL <https://polines.educaticss.com> hosts the website and database of the system. On the left side, the menu has seven options (see Fig. 3): home, users, sensors, readings, alerts, reports, and settings.

The "home" option shows a graph with the evolution of the minimum and maximum temperatures of the idler rollers (polines). The "Users" option allows the management of the users and assigns the role to be played by each person. The "Sensors" option allows registering the sensors installed on the idlers. The "Readings" shows the idlers list, and the temperatures read in a specific time window. The "Reports" option allows the user to download (in Excel format) the data read between two dates. Finally, the "setting" option is used to configure particular variables, for example, the minimum and maximum temperature allowed on the pole. If the value read is out of this range, the system sends a warning to the conveyor belt operators through a Telegram message.

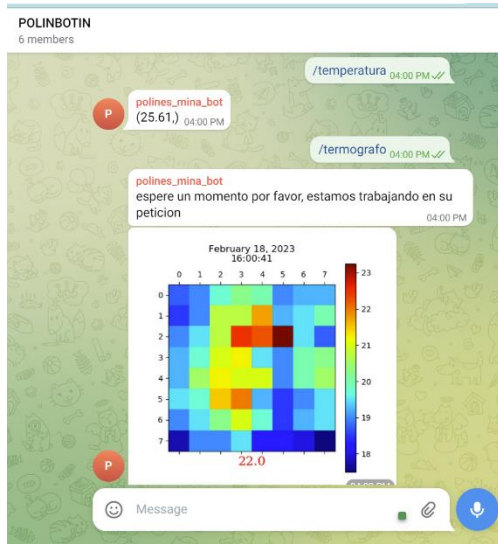
Fig. 4. Heatmap image requested from Telegram.

There is always a responsible for inspecting the operation of the conveyor belt. This person makes queries using his smartphone. Fig. 4 shows a thermal image or heat map requested by an inspector through Telegram social network.

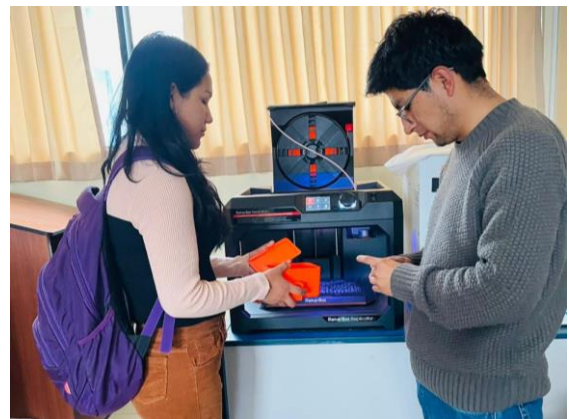
Fig. 7. 3D printer calibration.

As shown before, the system prototype has electronic devices, integrated circuits, connection cables, among others, which were covered by a casing that has ventilation. The case was built with a 3D printer that uses filament for printing. The 3D case for the prototype was printed in the Makerbot 3D printer. Fig. 7 shows the calibration of the 3D printer.

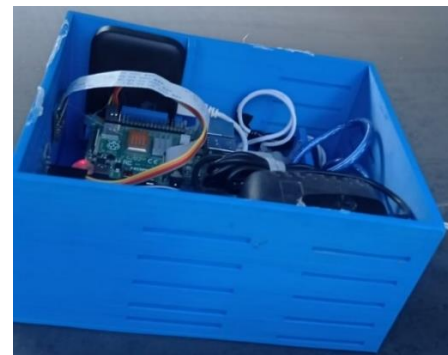
Fig. 8. Final prototype.

This casing should have certain characteristics to ensure proper functionality and protection of the device, for example, the casing material should be heat-resistant to withstand the temperatures reached in the mining environment, and the design should allow for easy access to the components of the roller heating detection system for maintenance and troubleshooting. The final prototype of the system is shown in Fig. 8.

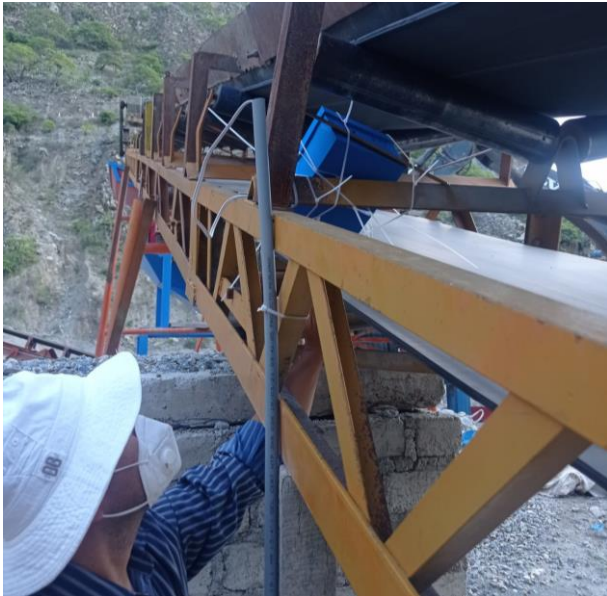
Fig. 9. Installing the prototype in the conveyor belt of ECONSA company.

Installing the prototype in the conveyor belt was not easy, because only two telecom operators provided Internet connectivity in these areas. Fig. 9 shows the installation processes of the prototype on the conveyor belt.

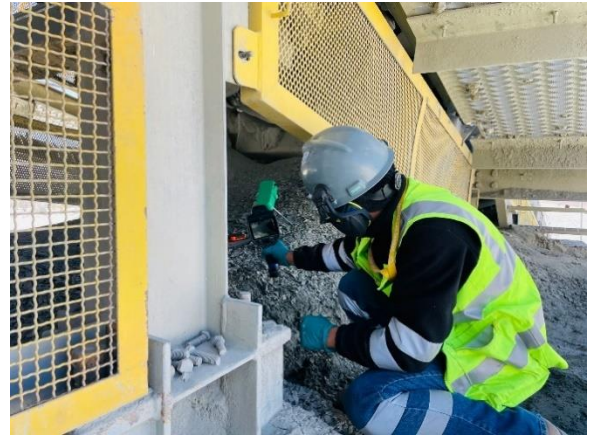
Fig. 10. The inspector comparing the temperatures in an idler roller.

In both cases, queries were delivered through the Telegram. The inspectors were able to ask for the temperature, thermographic image, photo and video of the idler rollers. Moreover, they verified that the temperature using the system had a difference of $\pm 2^{\circ}\text{C}$ compared to the readings of analog thermometers. Fig. 10 shows an inspector comparing the temperatures in the field.
